MADINGLEY HALL, CAMBRIDGE
Freeland Rees Roberts Architects

CONSERVATION PLAN
October 2002

MADINGLEY HALL – CONSERVATION PLAN

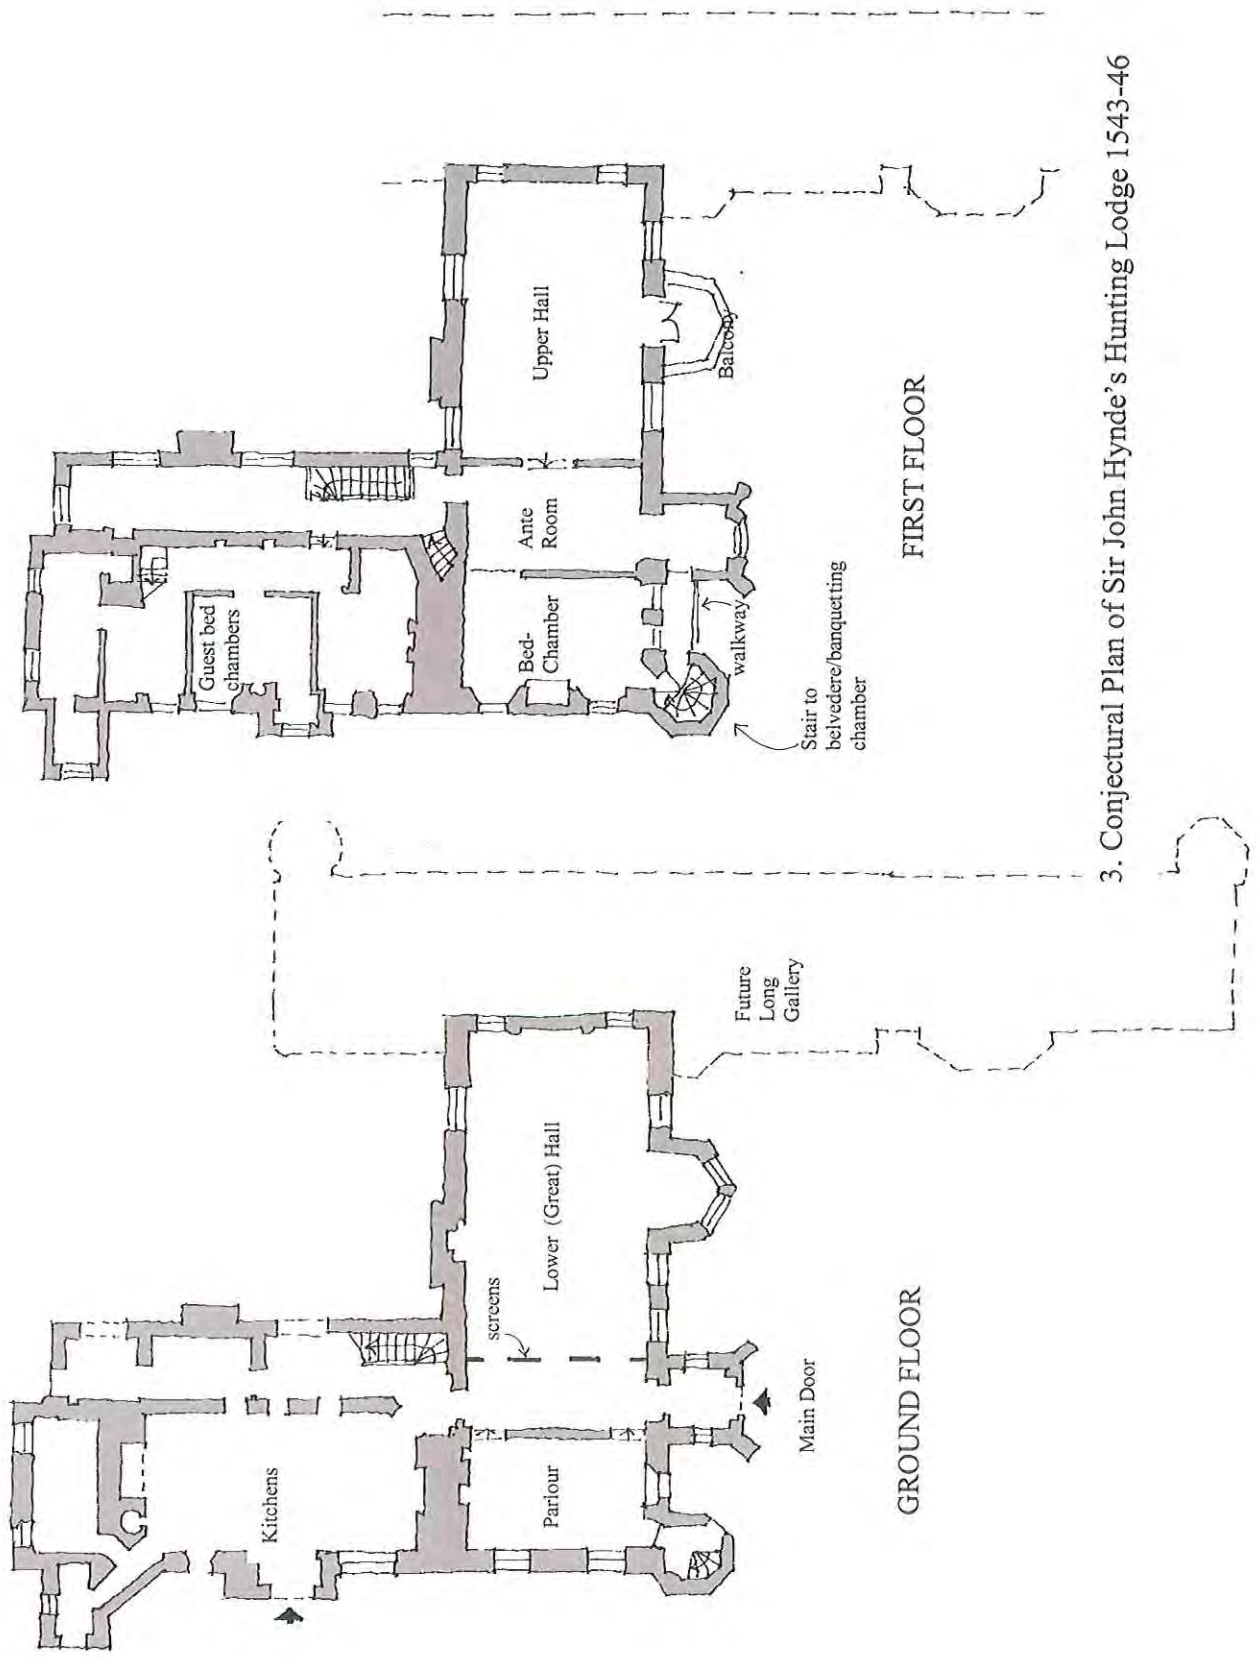
3. Conjectural Plan of Sir John Hynde's Hunting Lodge 1543-46

The house was L shaped. The east range had a hall, possibly two, one above the other, with oriel window, and a two storey entrance porch. The south range had kitchens on the ground floor and rooms, probably guest rooms, above. A series of fairly small chambers at the intersection provided bedrooms for Hynde and his special guests or family members. Evidence of the upper hall is unclear. Timbers were found behind the panelling at picture rail height in the Saloon in the 1950s but this would have been too high for an upper hall floor as suggested by RCHM. Windows and a balcony above the oriel window gave views across the parkland to the north, east and west and blocked up windows also found behind the panelling suggest that the floor was somewhat lower than the present Saloon floor.

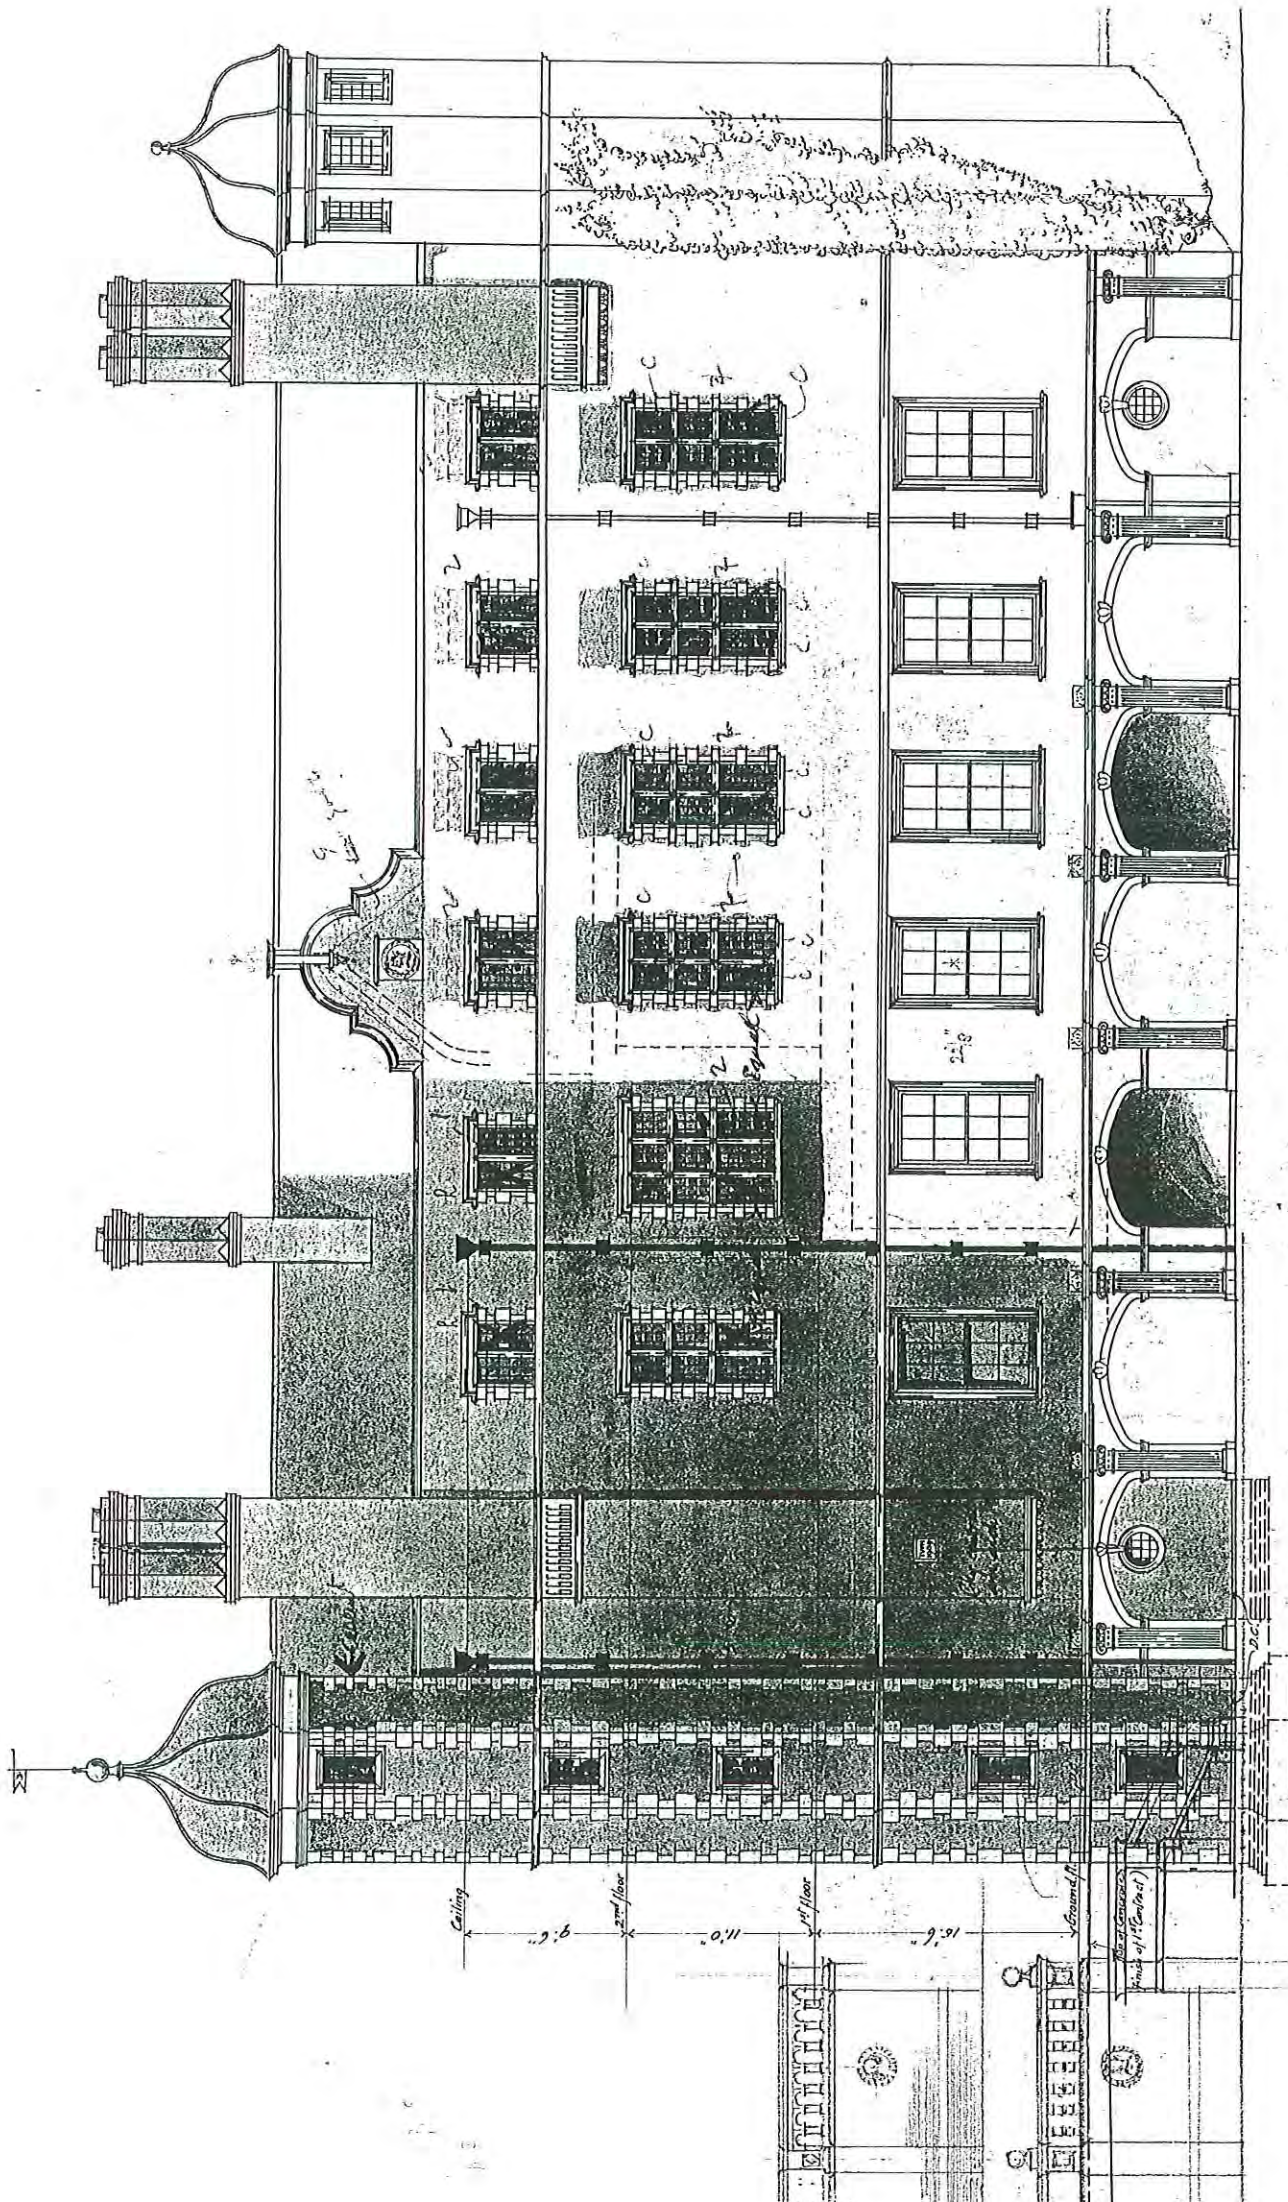
18. Gotch and Saunders' drawing of the proposed works to the North Elevation 1909

NORTH ELEVATION.

From the outset Harding's intention had been to replace Hurrell's single storey drawing room with a new extension to replicate as far as possible Sir Francis Hynde's north east wing, and, with the other repairs now complete, work on this ambitious new project could begin.

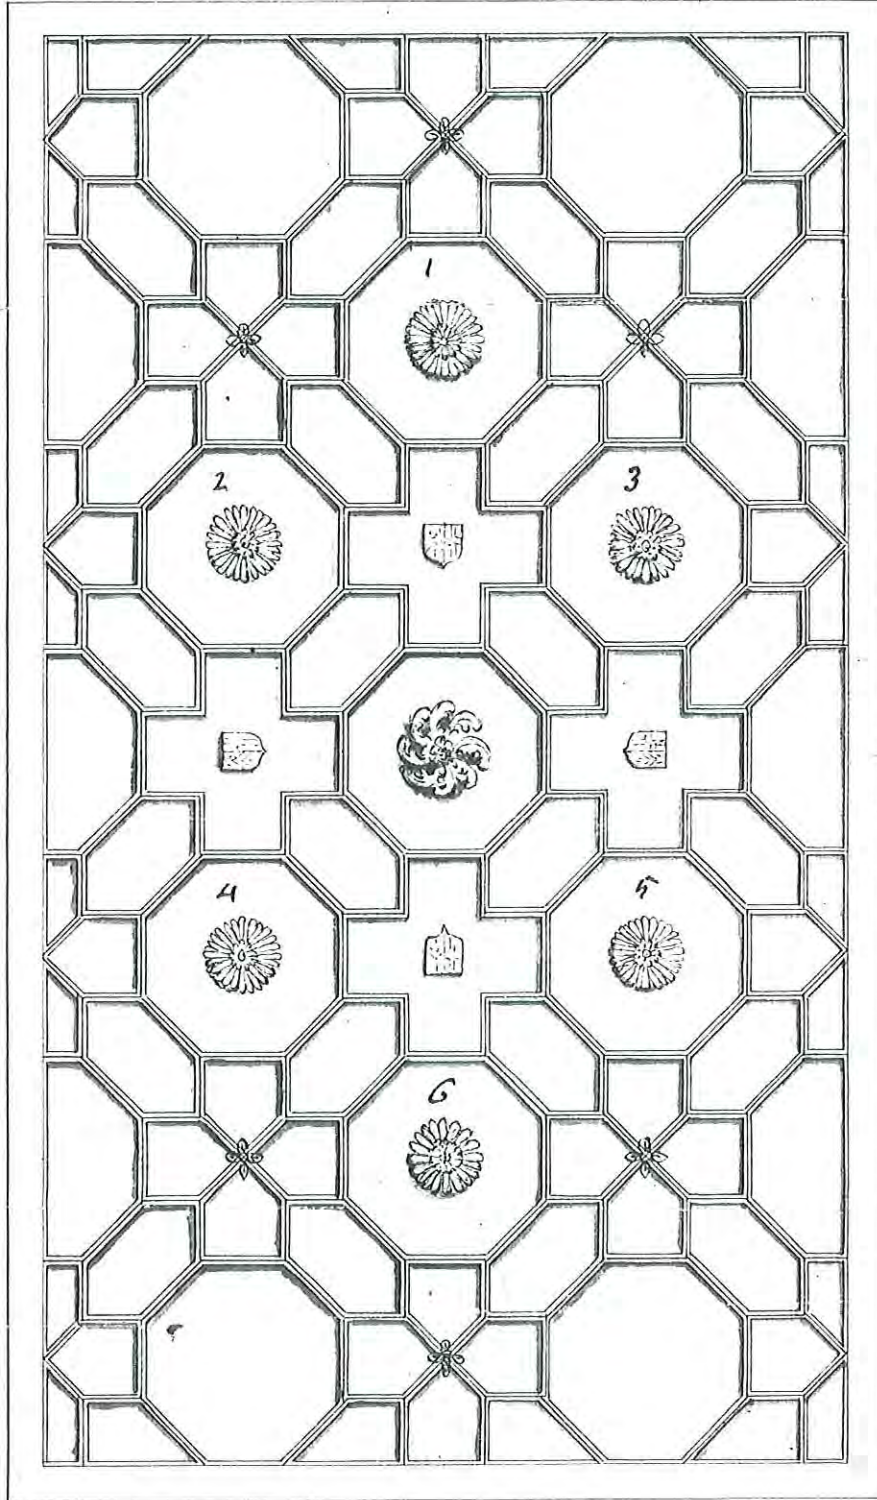
27. Walter Ambrose Hardings drawing of the Dining Room ceiling

date of this ceiling, July, 1765.
as given on a drawing of it,
lent by the Rev. J. Antrobus, of
Hatfield. See his letter
overleaf. The drawing agreed with this.
W.A.H.

The figures 1, 2, 3, 4, 5, 6, are to be coats of arms instead of flowers, & here are to be the same instead of flowers of arms set down in $\frac{1}{2}$ Plan.

In Dining Hall and Saloon the “wretched Victorian sash windows” were removed and replaced with stone mullioned windows and the Hall panelled. The Dining Hall and King’s Room ceilings were one of the several “bones of contention” that Harding had with his architect, the client invariably getting his way. Both ceilings were made by a Yorkshire plasterer named Mountain. The Prince’s Room was copied from a “Jacobean” ceiling Harding had in his home in Kirkstall with the arms of Edward Prince of Wales (Edward VI) cast from some oak bosses found at Madingley. The Dining Hall ceiling had the arms of Elizabeth I, badge of Edward VI and the Hyndes introduced into

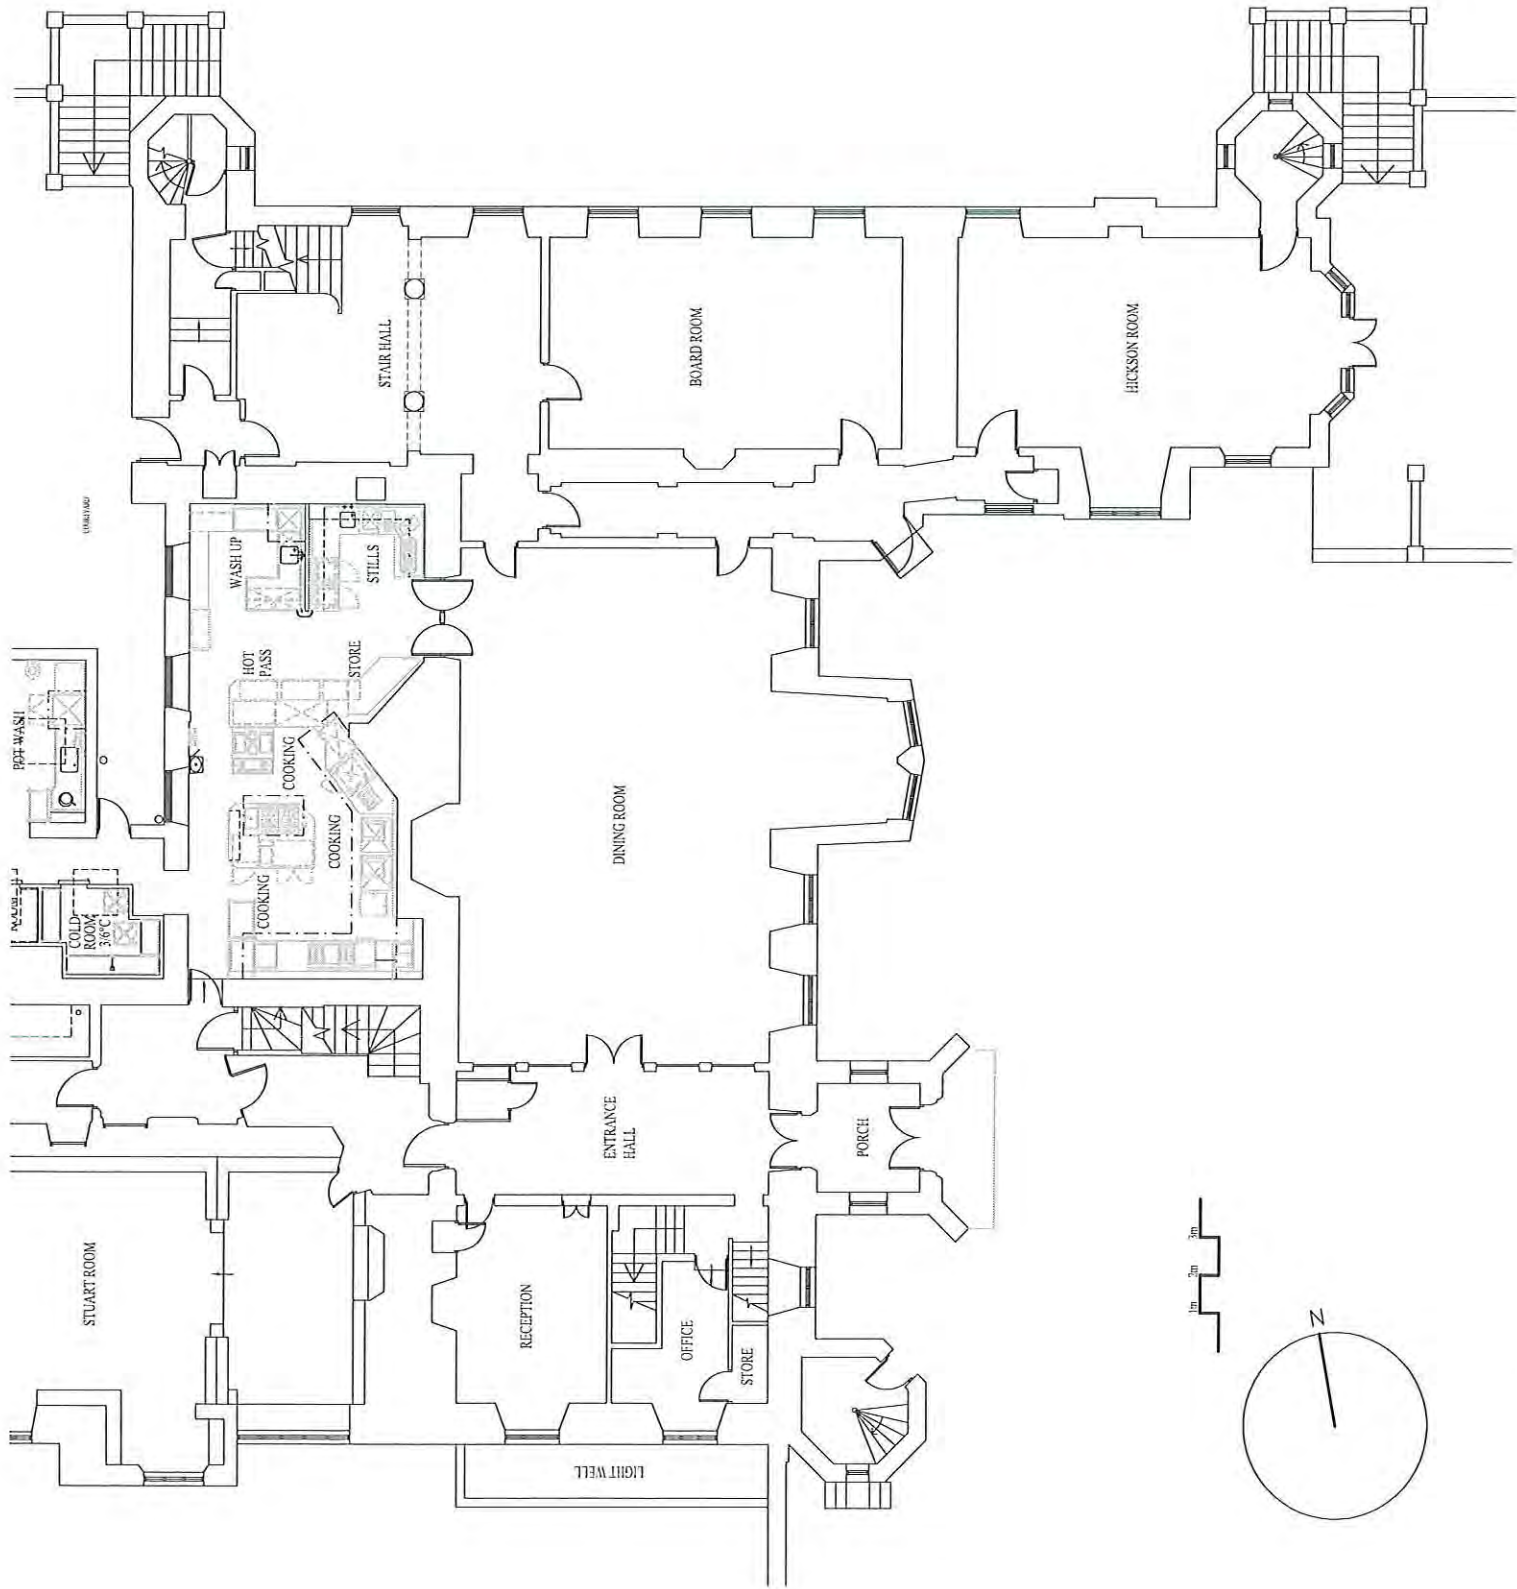
dwg no. 01

Madingley Hall: Conservation Plan
Ground Floor
